Aquatic Survey of Lower Dunkard Creek

Greene County

October – November, 2008

**Pamela J. Milavec
Water Pollution Biologist 4**

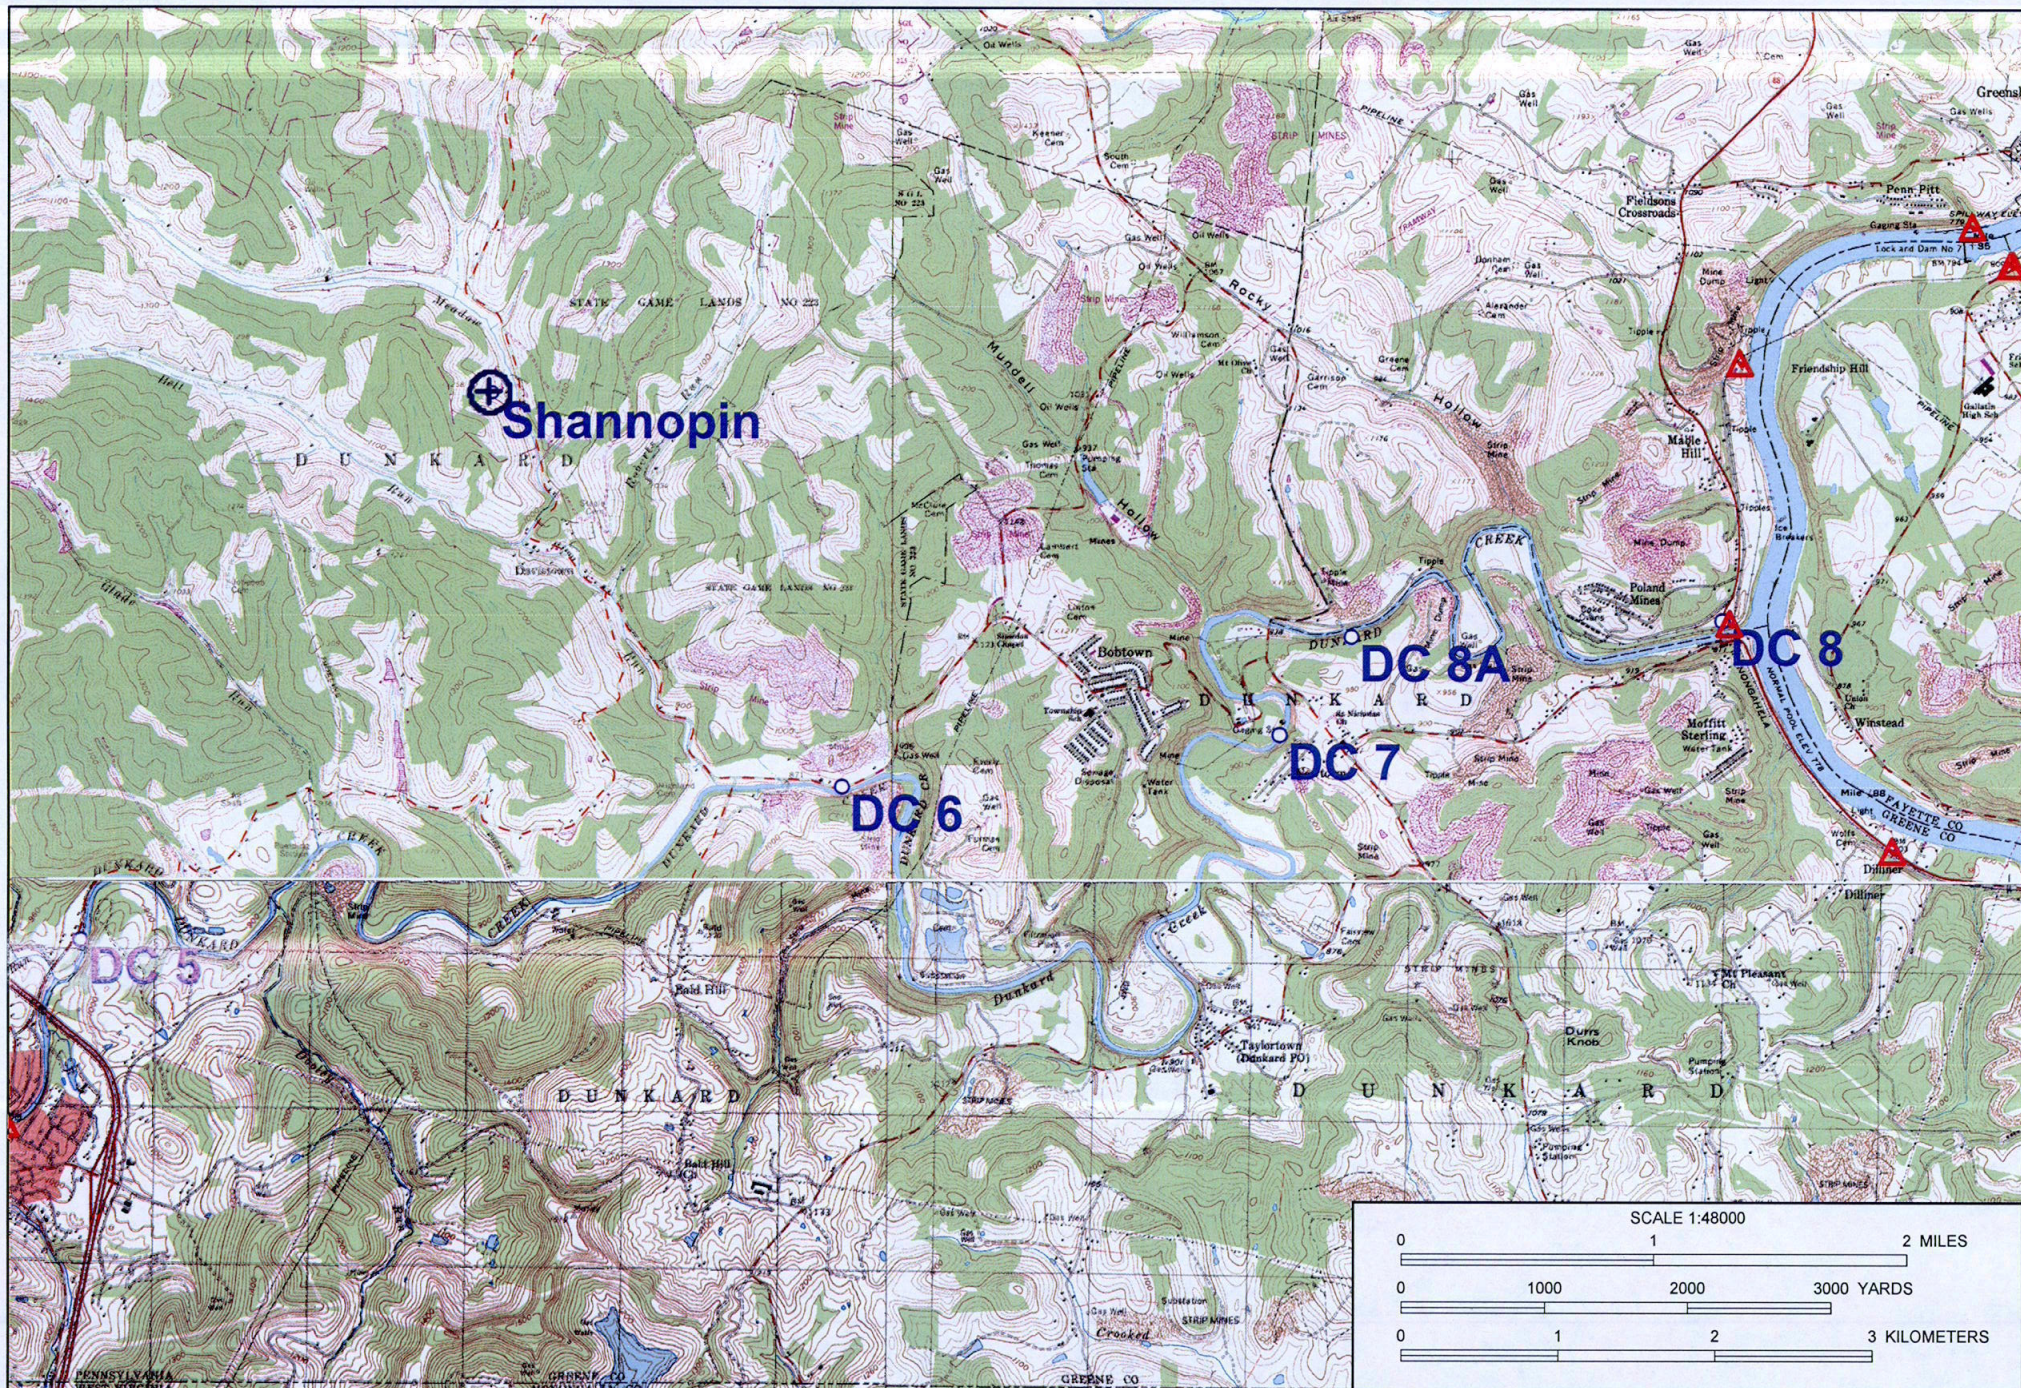
Location: 039° 45' 37.43" N 079° 59' 26.40" W
 Caption: Attachment A - Dunkard Creek Sampling Stations

Four stations were established on Dunkard Creek. These stations largely corresponded with earlier surveys completed by the Southwest Region and others. Station DC5 was located approximately four miles upstream of the treatment plant, just downstream of the town of Mount Morris (see map, Attachment A). Station DC6 was located just downstream of Meadow Run and the treated discharge, which is piped along Meadow Run and enters Dunkard Creek just downstream of the mouth of Meadow Run. Station DC7 was located near Bobtown, approximately five miles below DC6, and below several AMD discharges from abandoned deep mines. Station DC8A was located approximately two miles below DC7 and just downstream of additional abandoned discharges, and Station DC8 was at the mouth of Dunkard Creek, just upstream of the confluence with the Monongahela River. Station DC8A was established because the deep water conditions at Station 8 prevented macroinvertebrate sampling and fish sampling using a towboat.
